# Mwakirunge Dumpsite – A Simmering Disaster: An Environmental Impact Assessment

Okeyo Benards, PhD.

Pwani University, Kenya

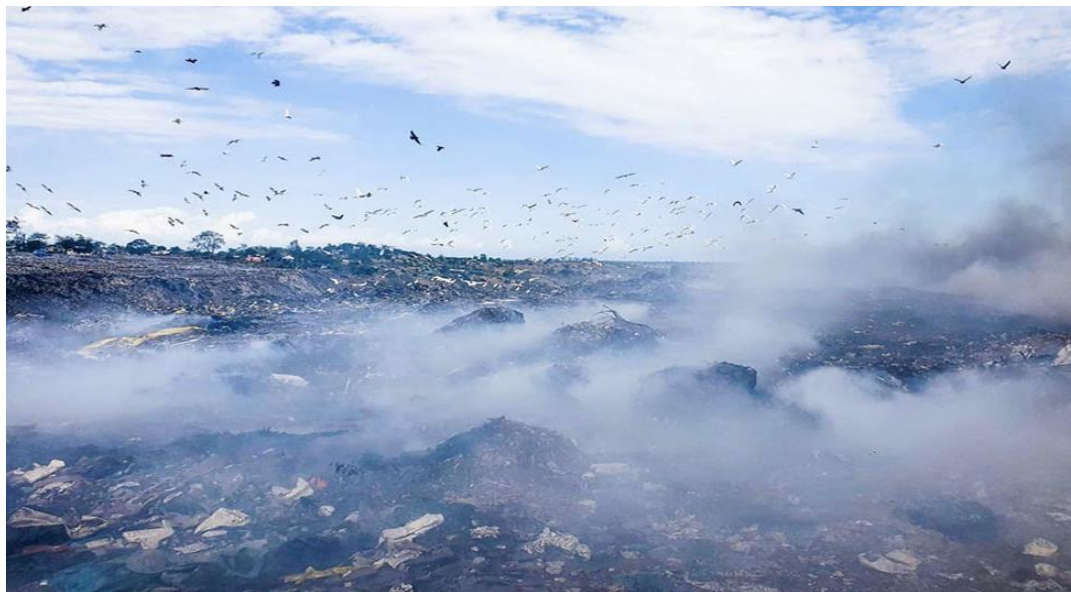
The biggest challenge of the dumpsite is the ever rising volumes of poisonous gases – spreading far and wide the vicinity of the dumpsite (see fig. 1). This spread can go as far as 5km away from the dumpsite. Both the persons within the 5km radius of the dumpsite are at acute exposure to the toxic air pollutants emanating from the dumpsite. The health risks posed to humans can be through one or a combination of the following pathways;

Fig. 1: the surface-ambient view of Mwakirunge during a normal day

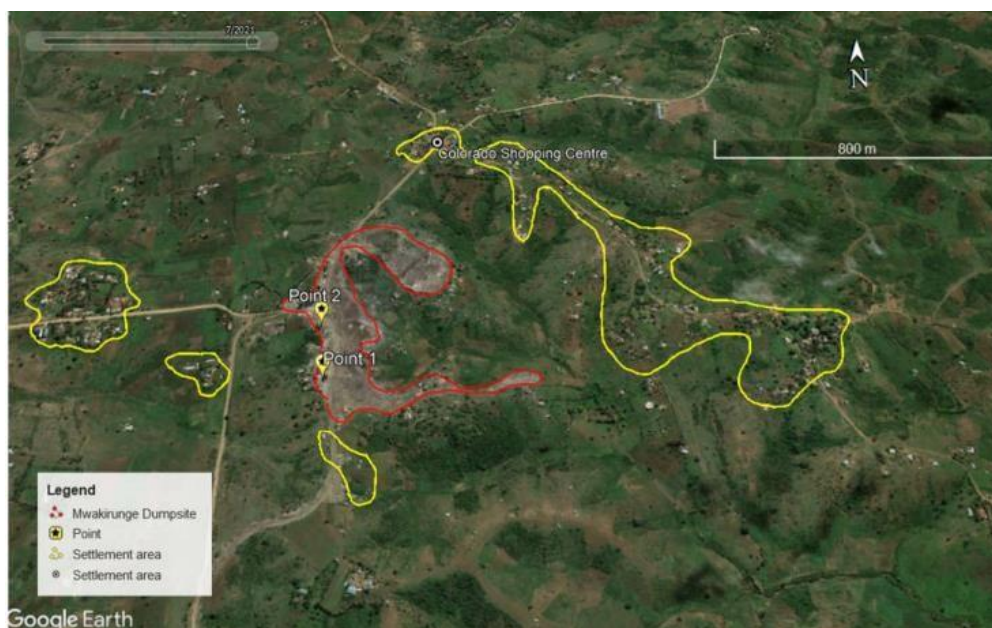
Ambient air quality monitoring of test parameters was done for four hours at each of the selected two points. The two monitoring locations were selected methodologically to represent the conditions at receptor locations as a result of the dumpsite open burning activities. Both locations were positioned downwind in relation to the wind direction.

Fig. 2: Aerial photo of the monitoring sites of the Mwakirunge dumpsite

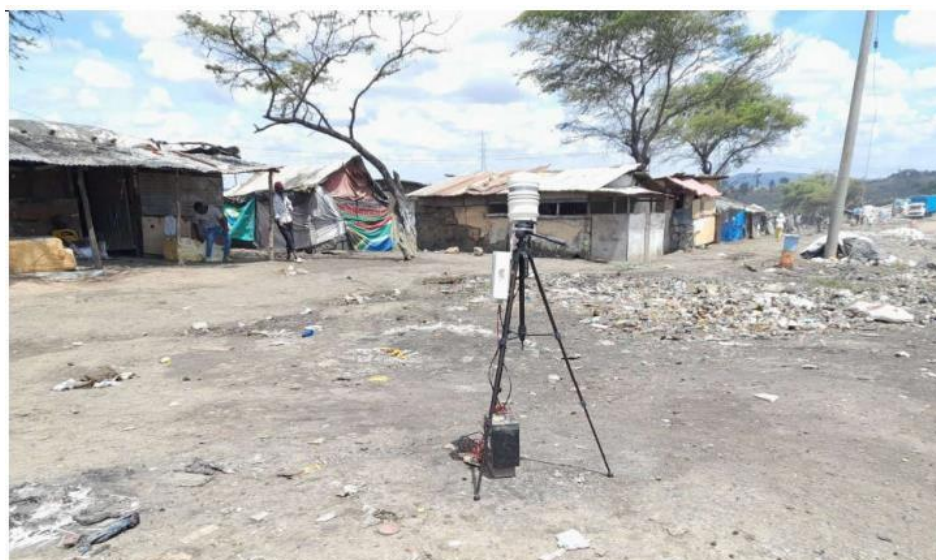
This study involved the sampling for the gaseous and particulate parameters. Ambient air quality monitoring was done by active monitoring methodology by use of a real time equipment (AQM Series). The AQM meter series, a state-of-the-art gas analyzer was used to measure the Particulate Matter (PM) and gaseous parameters levels using modern technologies (see figures 3 and 4 below).

Fig. 3: Sampling for Air Quality at Point 1

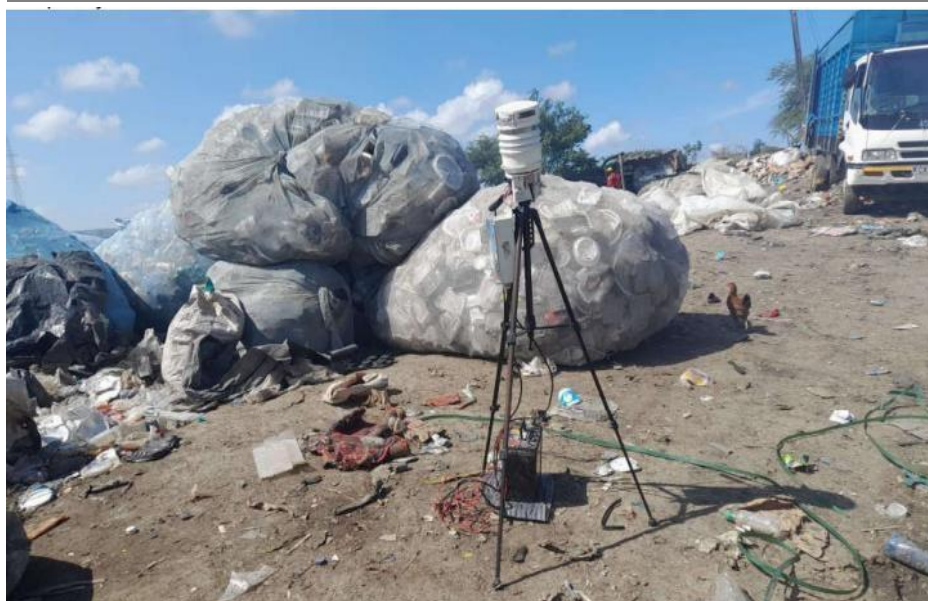
Fig. 4: Sampling for Air Quality at Point 2

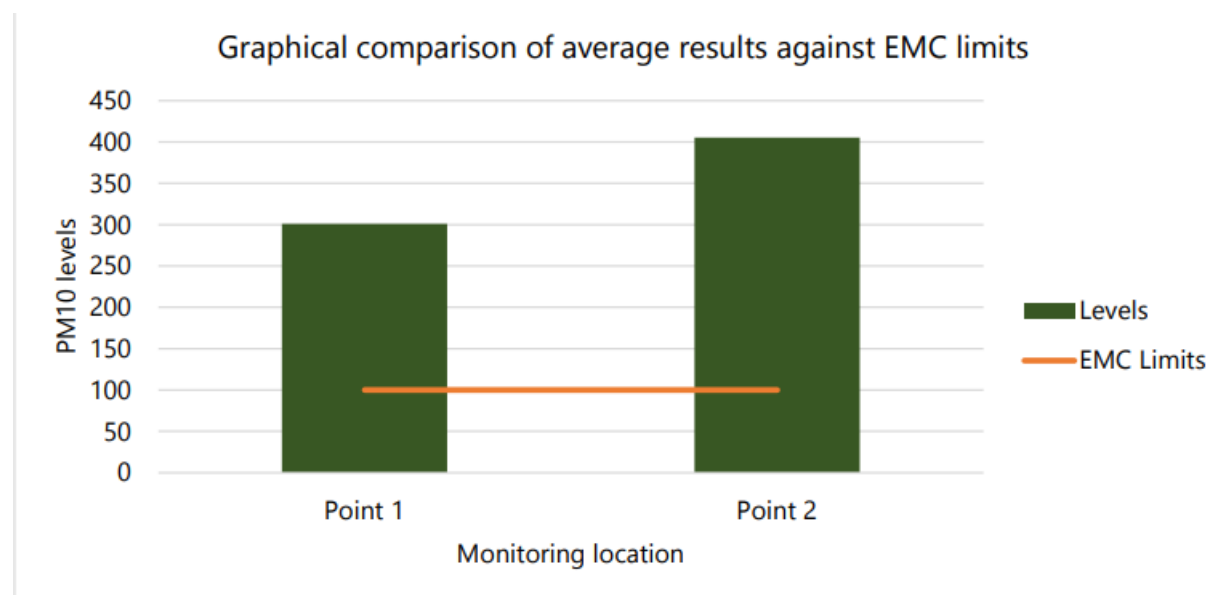
Fig. 2: Graphical comparison of Particulate Matter levels to EMC limits

As shown in figure two – the levels of particulate matter at the sampled sites **are more than triple the acceptable limits.**

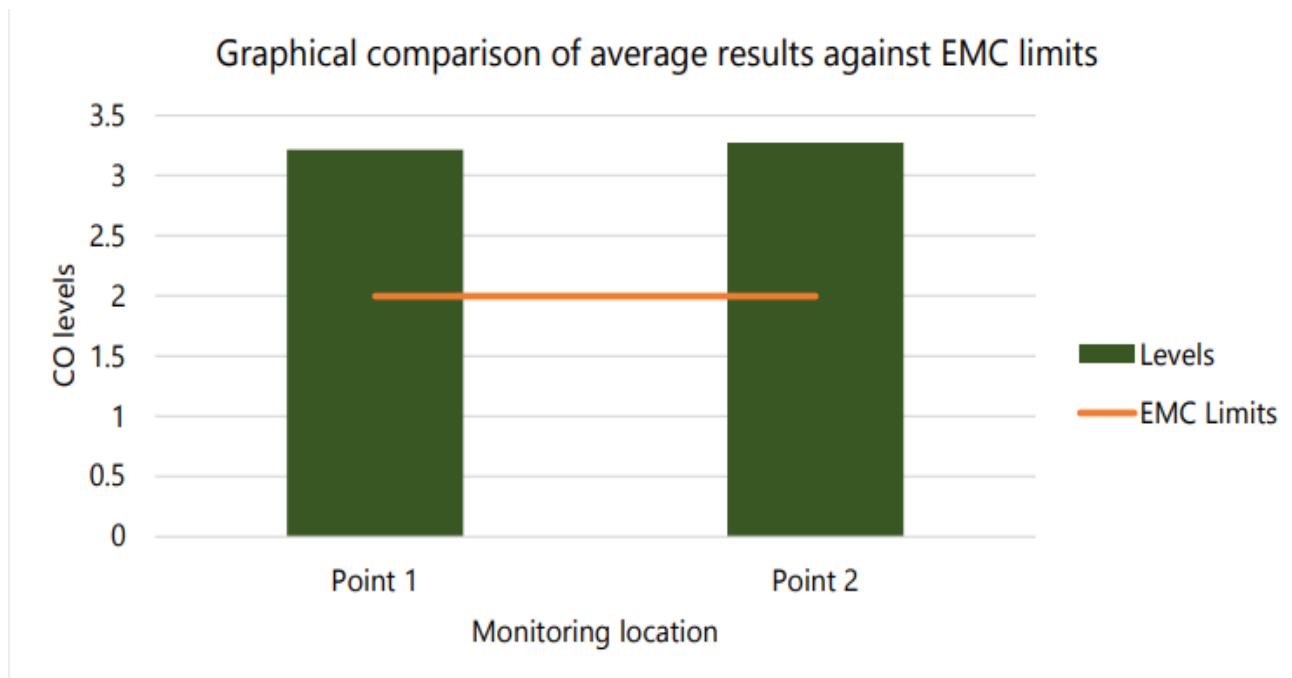
Fig. 3: Graphical comparison of CO levels against acceptable EMC limits

Results show that (figure 3) Carbon Monoxide levels at Mwakirunge Dumpsite is **almost double** the acceptable limits.

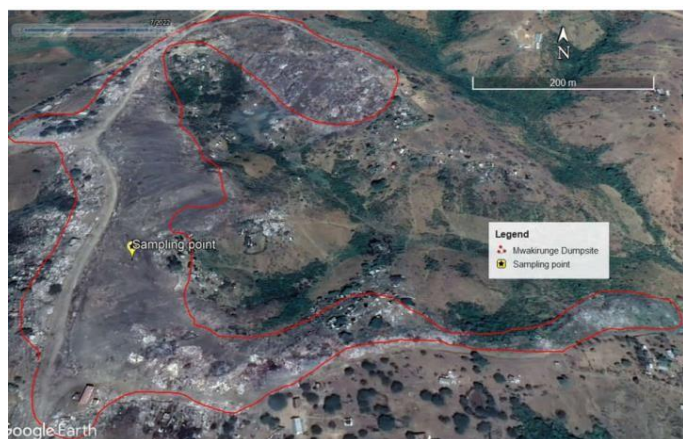
Leachates were collected at one sampling location. The location is indicated in the google map show below (figure 5)

Fig. 5: Leachates sampling site at Mwakirunge dumpsite

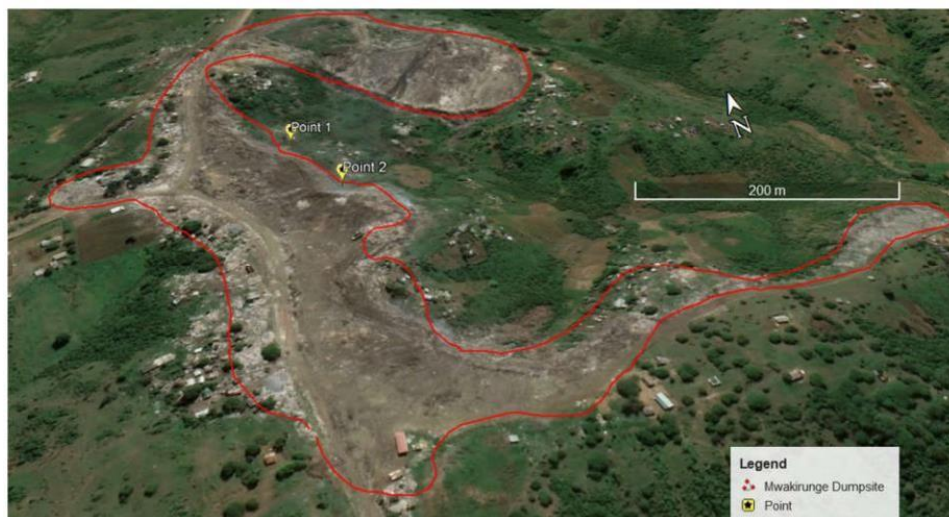
Subsurface soil samples were collected from 2 points and used to make one homogenous sample. Sampling locations are shown in the map below (figure 6):

Fig. 6: Soil sampling sites at Mwakirunge Dumpsite
