Recurrent Flood-Washed Flexible Pavement Failures in Wilberforce Island, Nigeria: Proposed Solutions

Isaac Oludayo Adedokun^{1*}, Ifeolu K. Adewumi²

¹Niger Delta University, Department of Physics, Faculty of Science, Wilberforce Island, Nigeria

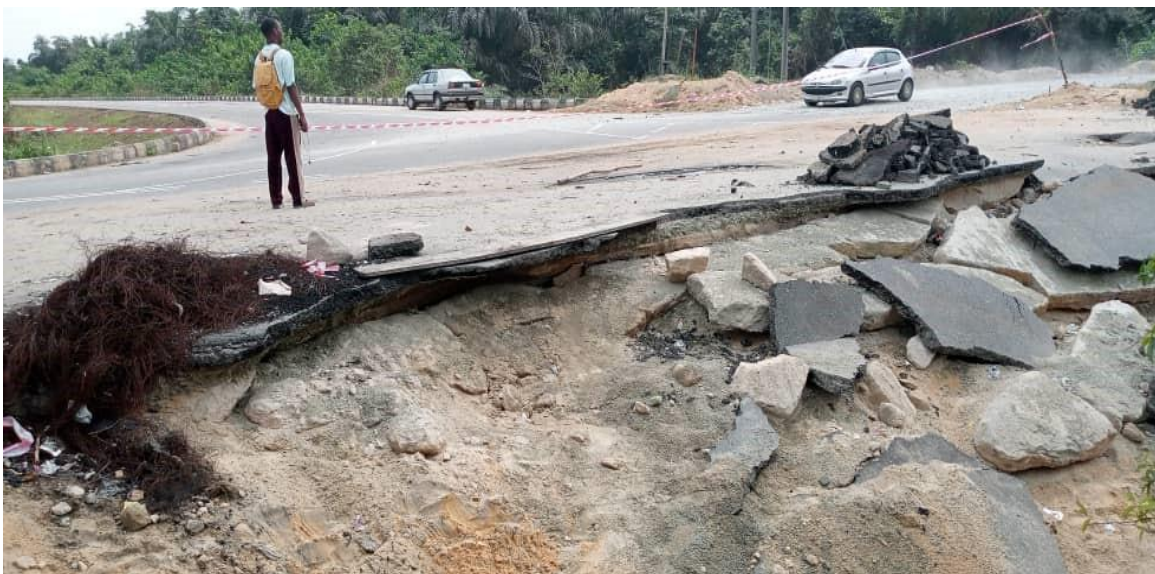
Plate 1: The eroded flexible pavement at the junction to the Cargo Airport along Amassoma Road (¹Adedokun, 2022)

The sand-filled base course method used in the road construction is more or less a levee and locations of the failures are all in stream bed flow with the pavement almost perpendicular to the direction of flow. This the

pavement is technically serving as a small earth embankment dam or levee that retains the flood water. With neither culvert nor French drain to channel the flood water to the other side of river course, the slope of the pavement was too thin to create enough head to resist the hydrostatic pressure of the accumulated water in the upstream side. This was responsible for the piping erosion that leads to the washing away of the sand used in paving the highway. The erosion was easy because there was no impervious core within the section of the highway.

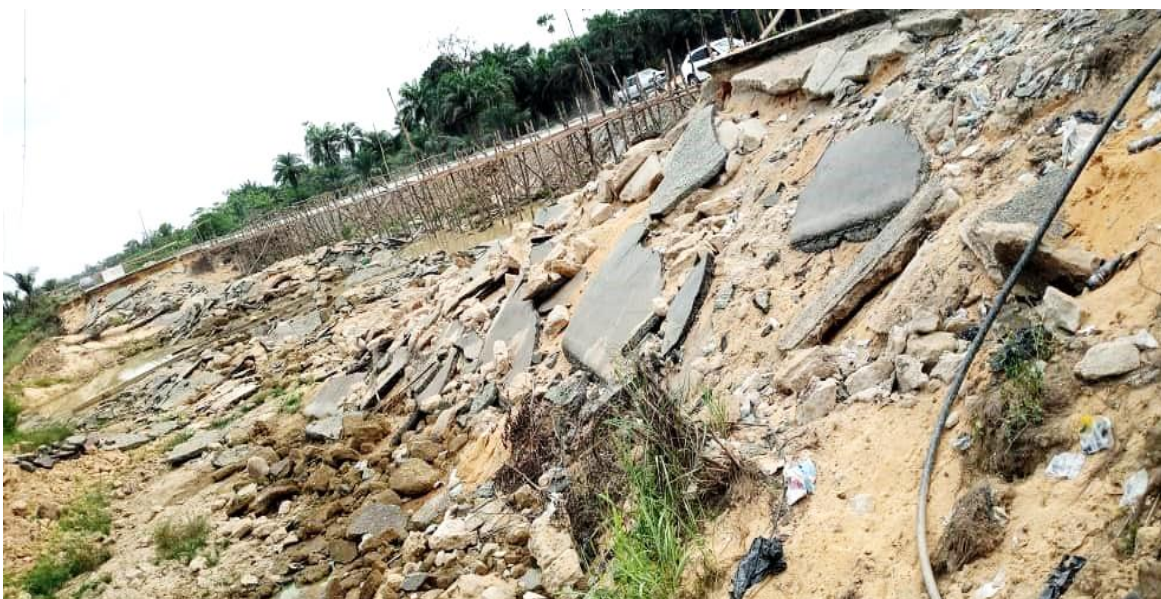
Plate 2: Footbridge constructed over the washed-off pavement to link Tombia community with Amassoma Road (Adedokun, 2022)

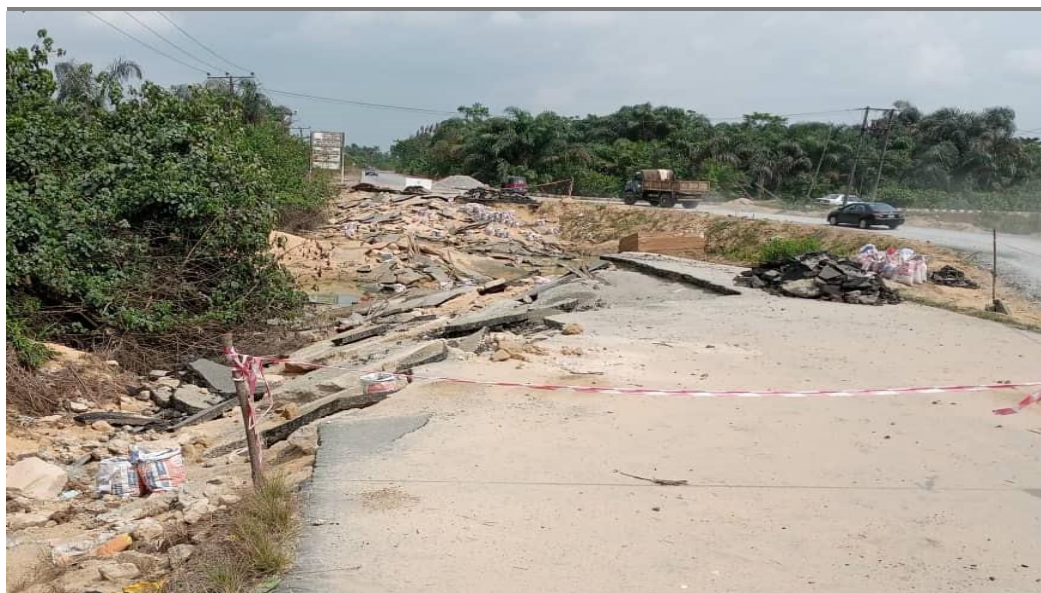
Plate 3: Reconstruction of the failed pavement along Ogobiri - Amassoma Way (Adedokun, 2022)

2. The modification of the pavement design around the frequently breached locations. The method of construction in riverine area, close to the ocean is to use dredged sand as both subgrade and subbase course beneath the riding surface of flexible pavement made with asphalt. However, the highway which is naturally raised above the surrounding terrain has become more or less a levee or small dam. The breached areas are more or less putting hydrostatic pressure on the walls of the highway. Since the slope at those locations and generally along the highway is steep, less than 1:2, it is better to increase the slope to 1:3 with riprap placed on the inner side which now serves as an upstream surface to the highway. This should then be backed with an appropriate size and length of culvert connecting the flood water to the downstream side. Within the upstream side which now serves as a Reservoir,

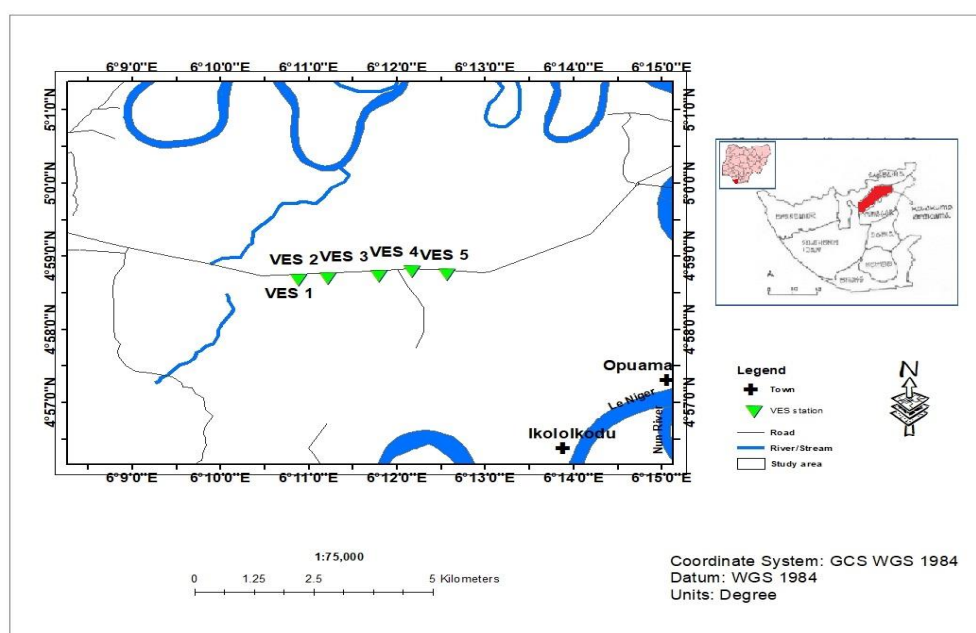
Figure 1: Map of Bayelsa State showing the study area and the positions of VES stations.

Five Schlumberger Vertical Electrical Soundings (VES) were carried out in the study area depicted as VES 1 to VES 5. The stations were carefully selected along the road under investigation. Abem Terrameter (SAS 1000) equipment was used with a maximum current electrode separation AB of 1000m and maximum potential electrode separation of 40m. The maximum depth of investigation is between 0.1 to 0.3 times the current electrode spread AB length (Bernard, 2003). Whenever current (I), was introduced into the ground, from the Terrameter, by means of two current electrodes (A and B), the potential drop (V) between a second pair of electrodes M and N placed in line in between the pair was measured and the value of Resistance R (V/I) displayed and recorded. The field measurements were taken at AB/2 1.00, 1.50, 2.00, 3.00, 5.00 6.00, 8.00, 10.00,200.00, 250.00, 300.00, 350.00, 400.00, 500.00m. While corresponding values of MN were 0.25, 0.5, 1.0, 2.5, 20.0m With the electrodes driven into the ground for not less than 20.00m, good contact with ground was maintained and accurate survey method required that the distance between potential electrodes (MN) and current electrodes (AB) must be $5MN \leq AB$, Fig. 2. The product of the resistance R (V/I), read from the instrument, T, and the Geometric factor K which has to do with the arrangement of electrodes gives the apparent resistivity and for the Schlumberger electrode configuration used, $AM = MN = NB$, $AT = TB$, (Telford, *et al.*, 1990).
